**SYSON-HILLE
and
ASSOCIATES**

July 14, 2008

Re: **POWLEDGE vs. GENERAL MOTORS CORPORATION**

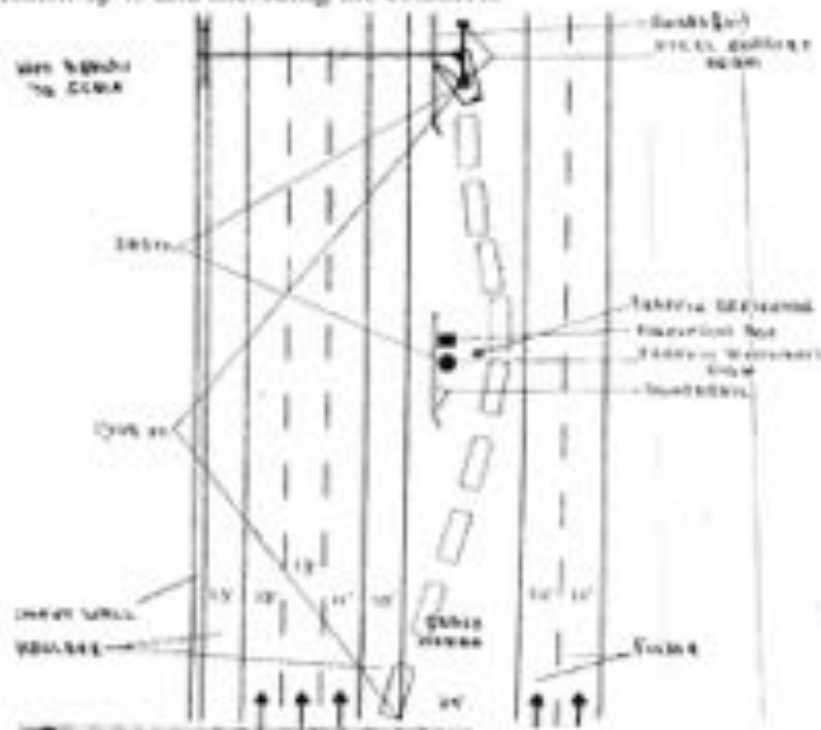
D. To determine if this was an intentional event, one must also look at the events before the actual impact. The police accident diagram illustrates the vehicle movement up to and including the collision:

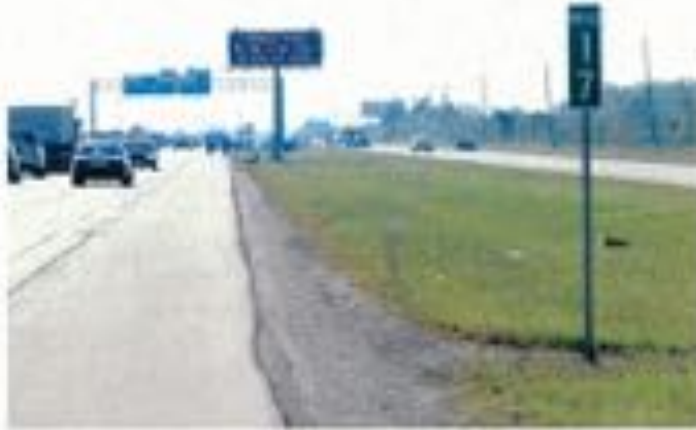
- G. After his departure from the southbound travel lanes of I-45 into the grass median, Mr. Powledge was able to steer and control his vehicle such that he managed to avoid a guardrail, a large electric box, a reflector post, and a traffic information sign pillar by moving toward the opposite side of the median. Based on the initial travel path of the Powledge vehicle after the vehicle left I-45, it appears that Mr. Powledge was trying to get onto the feeder road.

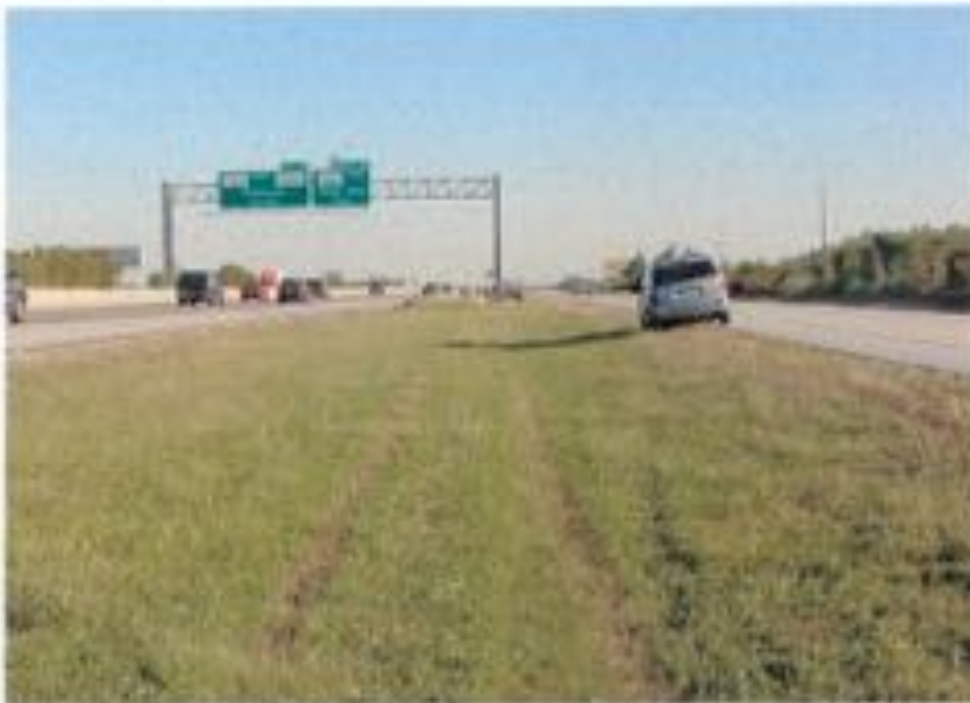
- K. Scene measurements by Scientific Analysis regarding the grass median include: width 50'; west side slope is 7 degrees; east side slope is 10 degrees; depth is 2"; flow line is 24' wide. The sloped sides would re-direct Mr. Powledge's vehicle back to the center of the grass median and make steering even more difficult to the right (toward the feeder road).

The re-directed motion of the vehicle back to the left (middle of the median) is evident in numerous photographs. As Mr. Powledge's vehicle moved left toward the flow line of the median and the deflated tire and bent wheel affected his steering and control capability, these conditions would tend to straighten out the vehicle into the lowest portion of the median.

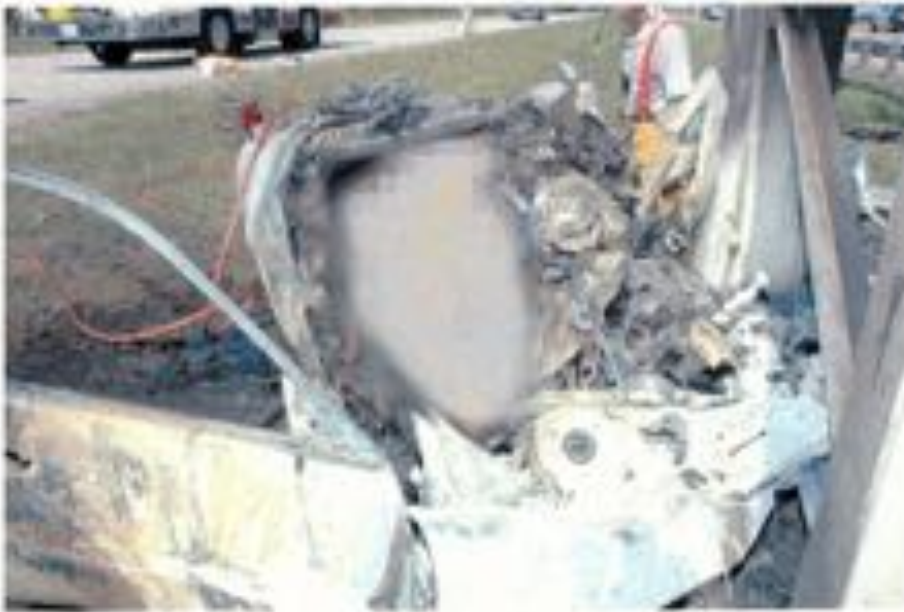
- M. During the last 700' of this accident after striking the concrete culvert with the left front tire, Mr. Powledge's brakes were ineffective, his engine was racing and his steering was not overly effective since the left front tire was deflated and his left front wheel was bent.
- N. Even though the deflated left front tire and damaged wheel affected Mr. Powledge's steering and control capability, there is evidence from the police photos that clearly demonstrate that Mr. Powledge's vehicle did not strike the sign support structure in a direct head-on manner. Instead, these photographs show that the impact was offset to the far left-side of the vehicle consistent with a person that was trying to steer around the obstacle.

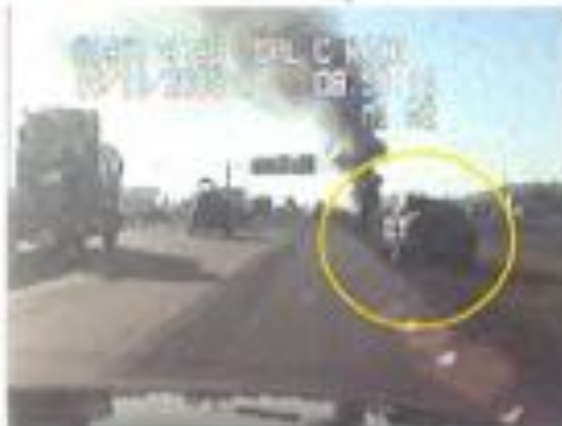
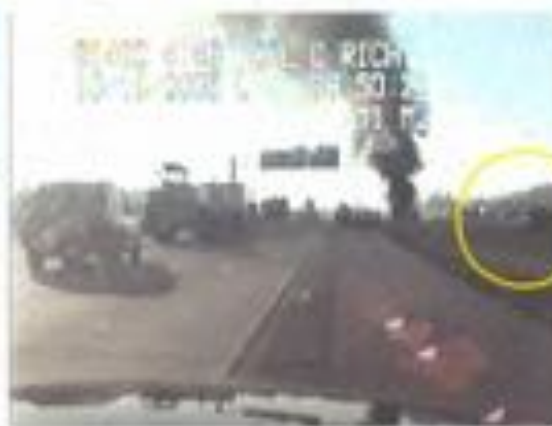
- V. I also watched Corporal Rich's cruiser video and noted that two trucks had pulled off into the median on opposite sides while the Powledge vehicle was still on fire. The police photographs after the fire do not show that tire marks were left in the grass median from either of these vehicles even though we know they pulled onto the median grass and stopped.

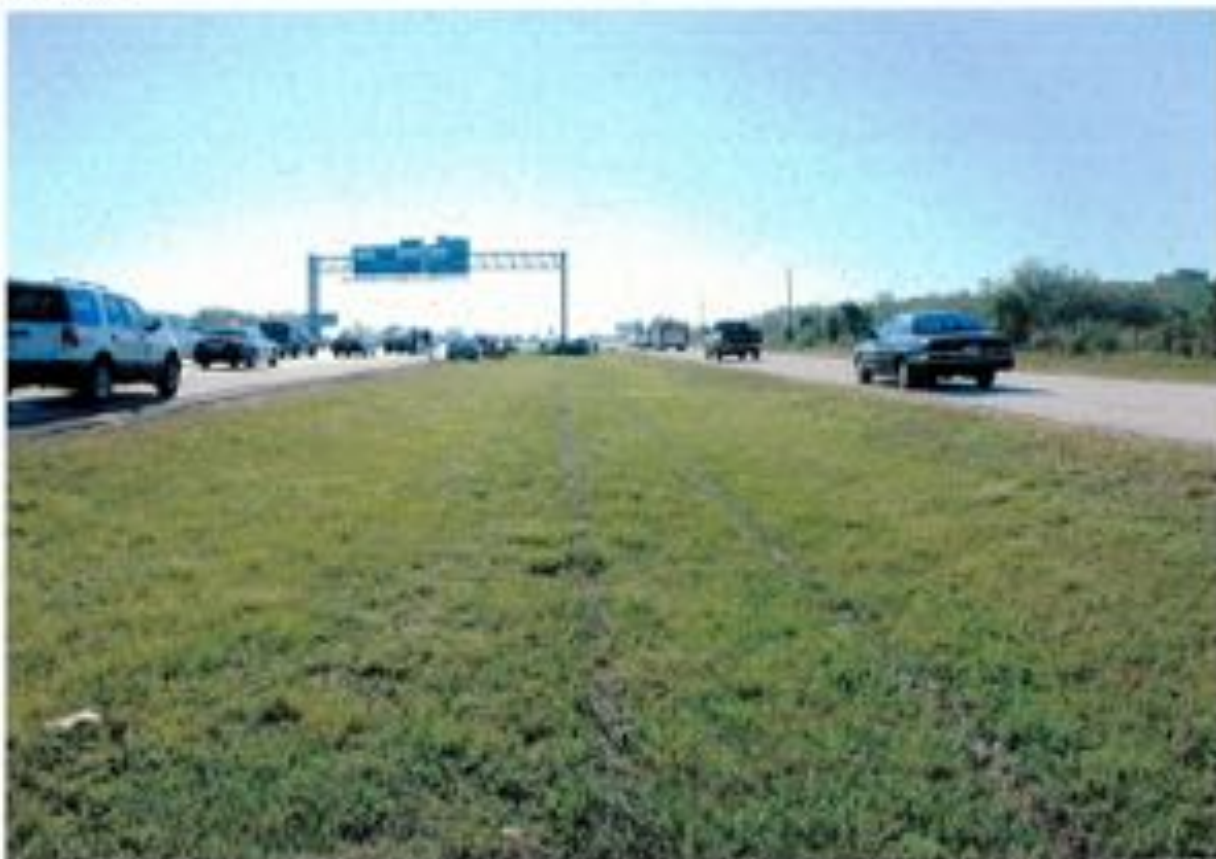
- W. I pulled the National Weather Service data for rainfall in the area to determine if the tire marks from the Powledge vehicle that were photographed by the police and the Williams' could have been due to wet ground. According to the two reporting stations for the National Weather Service for this area, there was no precipitation from October 11-18. (**Attachment B**). As such, the tire marks in the grass median cannot be attributed to wet ground conditions.

- X. Knowing that there were at least three other vehicles that were clearly in the grass median, this begs the question, why didn't these other vehicles leave any tire marks in the grass median when the Powledge vehicle left such well-defined tire marks? The answer is simple. The Powledge vehicle's rear tires were braking while the front tires were accelerating. The other vehicles' in the grass median did not experience a similar condition as the Powledge vehicle. The fact that these tire marks are still present 12 days (date Scientific Analysis photographed scene) after this accident reinforce the dramatic nature in which the tire marks were made.

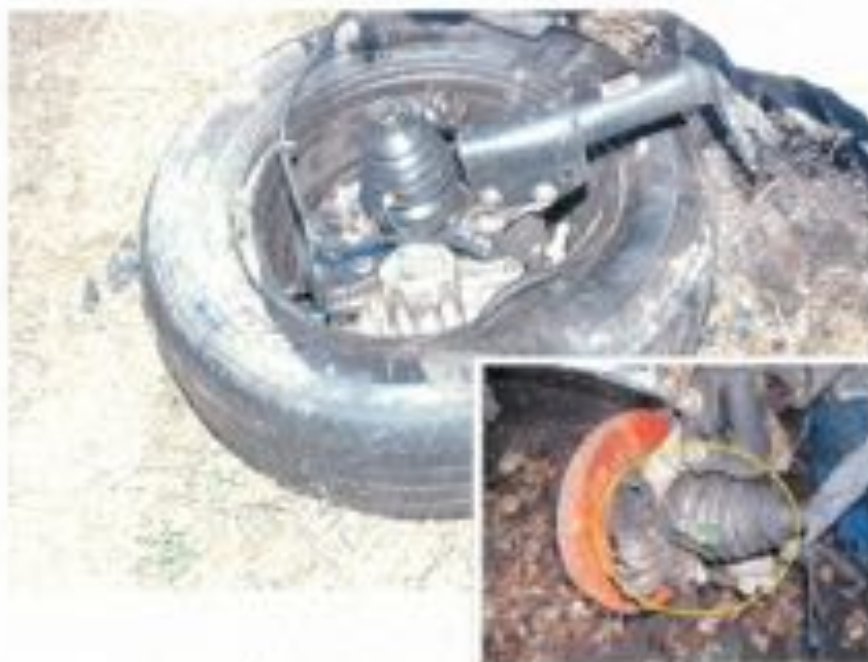
- A. Based on the tire marks in the grass median, the evidence is overwhelming that Mr. Powledge was braking at the time of the impact, and that he had been for a lengthy period of time before the impact. Naturally, the question becomes: why did his vehicle not stop?
- B. Contrary to GM's position in its build sheet for this particular vehicle, and in its answers to discovery, the subject vehicle clearly does have ABS components in place. These components are only used on ABS systems and were connected to the vehicle's wiring harness.

- C. In fact, the service manual for this vehicle shows that Malibu Classic vehicles with hub mounted speed sensors have anti-lock brake systems.
- D. So why would the vehicle's engine be racing when the brakes were being applied hard enough to bend the brake pedal, overheat the brake pads and leave defined tire braking marks?

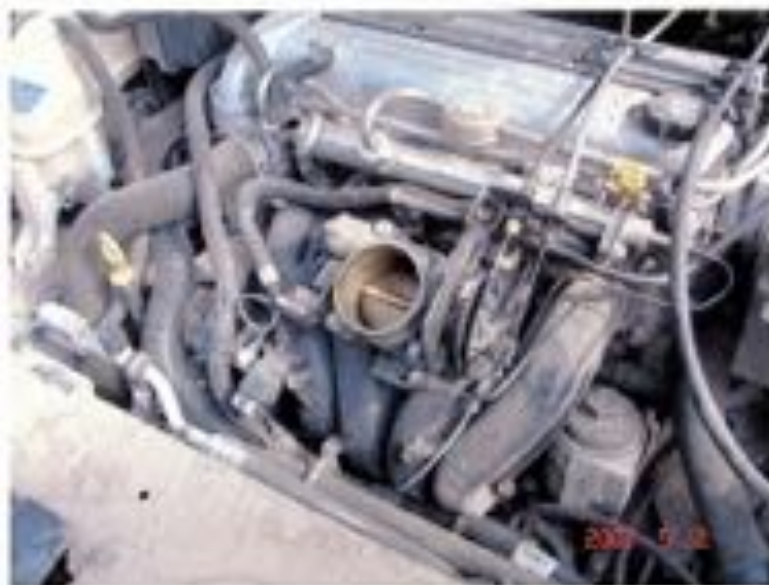
- J. I then inspected the power train of an exemplar 2004 Malibu Classic. The throttle was controlled by two cables. One cable attached to the throttle pedal, while the other attached to a stepper-motor type cruise control.

- K. The 2004 Malibu Service Manual also indicates that, when a Malibu Classic is equipped with a cruise control, both accelerator pedal and cruise control input to the throttle are through pull-type cables. However, it should be noted that an exemplar 2004 Malibu built just 3 months prior to this Malibu Classic had drive by wire throttle system and integrated electronic cruise control.
- L. There is a number of customer complaints from other Ecotec engine based vehicles indicating that this design occasionally results in an unwanted acceleration condition. (Attachment C.) Some of the complaints demonstrate that the throttle return spring, or other device to close the throttle (if the throttle cable, or throttle control electro-mechanical systems fail), is inadequate to close the throttle and prevent a runaway vehicle.

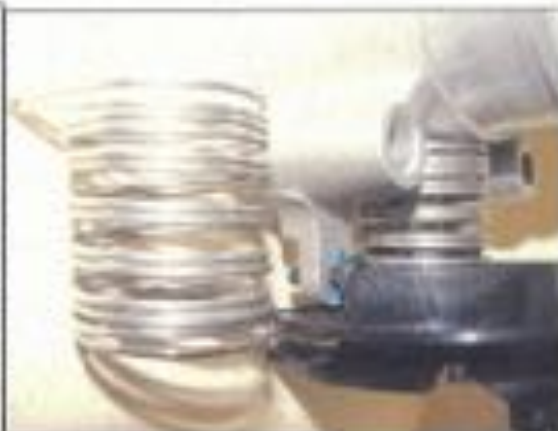
- N. If the throttle fails to close promptly when the driver takes his/her foot off the accelerator pedal, the throttle control system is in violation of FMVSS 124 (Accelerator Control Systems), both S5.1 and S5.3, which require redundant systems to close the throttle, and that the throttle close within a second after the gas pedal is released. If the cable guide moves off the throttle shaft, both springs disconnect from the throttle, and the throttle will not close. Such a single point failure is prohibited by FMVSS 124. An exemplar throttle body was purchased and disassembled to study the two spring connection. GM uses two springs that connect at the same positions. This unitized dual spring serves as the two distinct energy sources that FMVSS 124 requires to close the throttle. It is clear that GM's design of this unit is a violation of FMVSS 124 S5.1.

- O. A throttle control system, like that on the subject Chevrolet Malibu Classic, which does not meet FMVSS 124 is defective and unreasonably dangerous.
